PUBLIC WORKS MEETING - CITY OF ROELAND PARK
4600 W. 51ST Street, Roeland Park, KS 66205
Monday, August 9, 2010
6:10 P.M.

Roeland Park Public Works Engineer's Report

Stand Alone Drainage problems
August 9, 2010

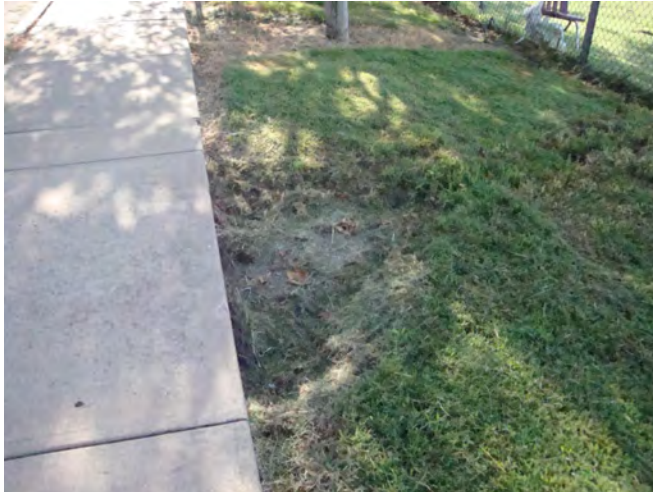
1. 48th Street and Reinhardt: Storm water flows to the street between Reinhardt and Canterbury where it floods the street. The water flows over the south curb and flow through the north Meige campus to the detention basin and underground system located in that area. There are no inlets located along 48th street. There are only flumes constructed beneath the sidewalk to allow water to drain away slowly after a rain.

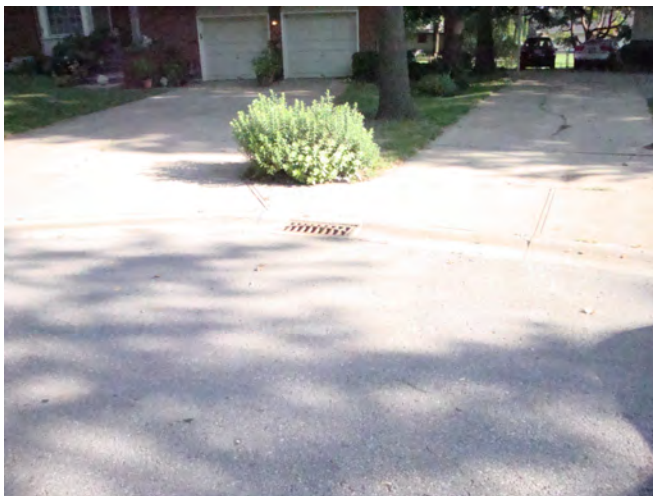
2. 47th Place Cul-de-sac East of Mohawk: Storm water flows from yards and rooftops upstream of the cul-de-sac. The water collects in the low point located on the north side of the cul-de-sac where it is collected and into a small grate inlet and piped to the north, through the side yards of the homes. The system capacity is exceeded routinely and the excess storm water must flow across the surface of the yards as it flows north.

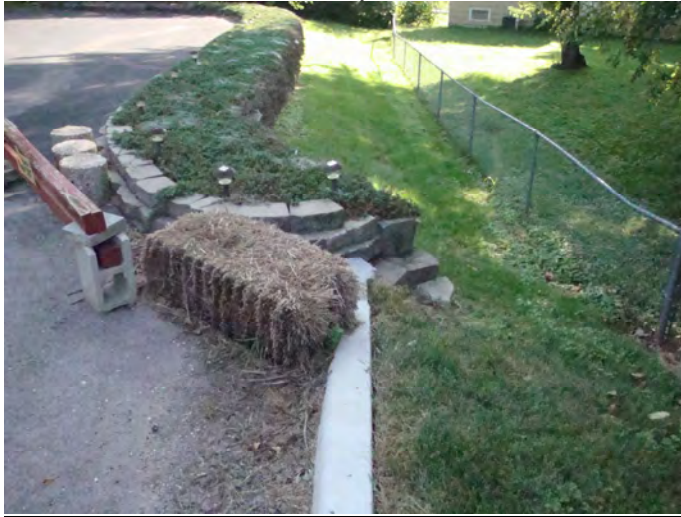
3. 48th Street Place: Storm water flows from yards and rooftops to a point on 48th Place. The excess flows must flow down the yard slope along a homeowner's wall to the lower ground to the east. The water then flows across side yards as it flows to Neosho lane to the east.

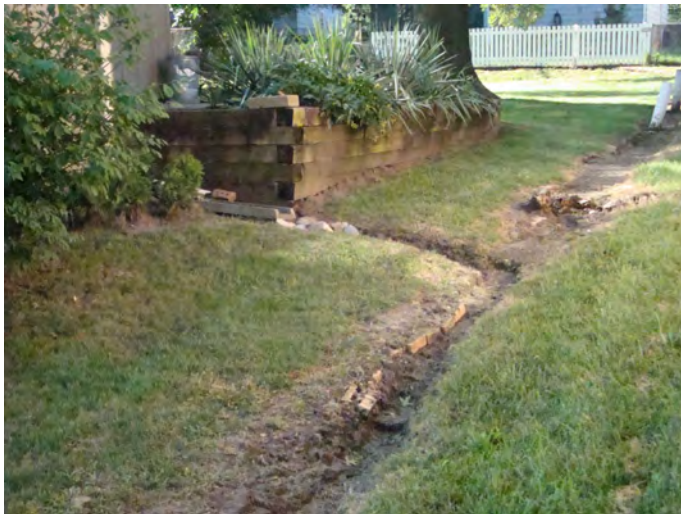
4. 47th Street: Excess storm water from rooftops and yards drain from the south and east through the back yards and exits through the side yards to the north onto 47th street. The homeowner in this location has graded the yard to collect and convey water at the perimeter of the property.

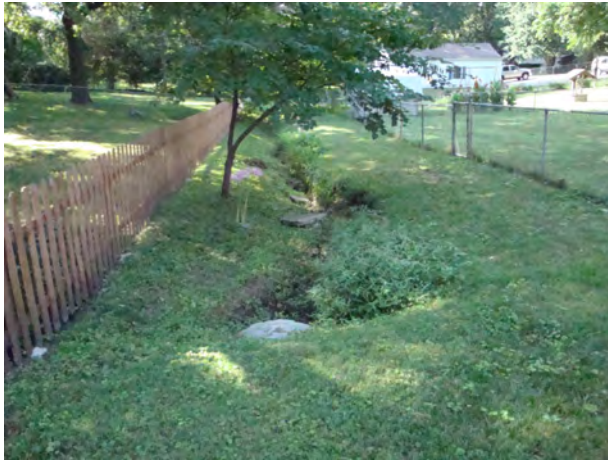
5. Open Channel between Buena Vista and Clark: This Channel is a natural channel extending from south of 50th Street southeasterly to 53rd street. The channel is small and the storm water spreads out and fills the back yards with water as it flow down the valley. There are several out buildings along the rear lots that would be in the flow path during large storms. Additionally there is a segment of underground pipe north of 52nd Terrace that has joint failure and sink holes over the pipe.

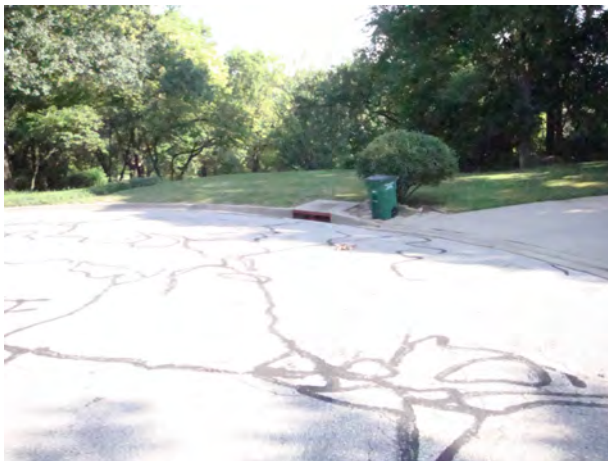
6. Birch St. Cul-de-sac north of 48th Street: The storm water from yards and rooftops collect in the street and drain into one single curb inlet that has small pipe drainage away into Nall Park to the North. When the capacity of the pipe is exceeded overflows go over the curb and flow away down the slope to the north. The water flows across the hiking path in the park before reaching a drainage channel in the park.

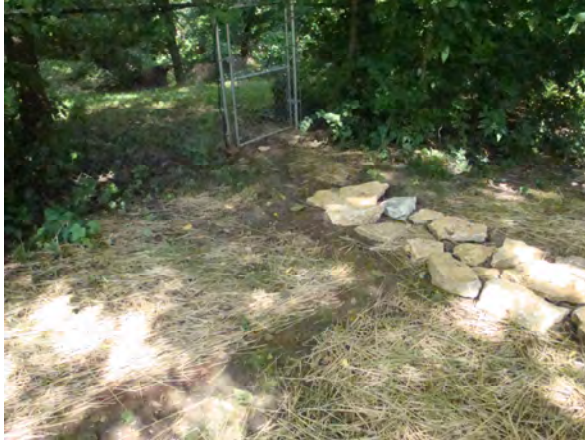
7. West corner of community center: The excess storm water in this area collects and runs along the eastern property line and away to the north. At the north corner of the property the flows go down the path in that location. The water then is making its way into Nall Park where it crosses the hiking path before entering into a channel.

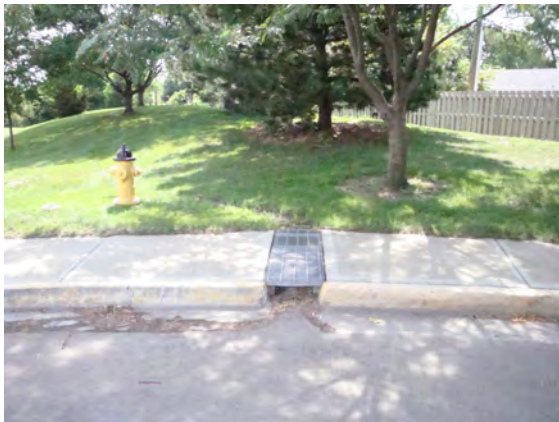
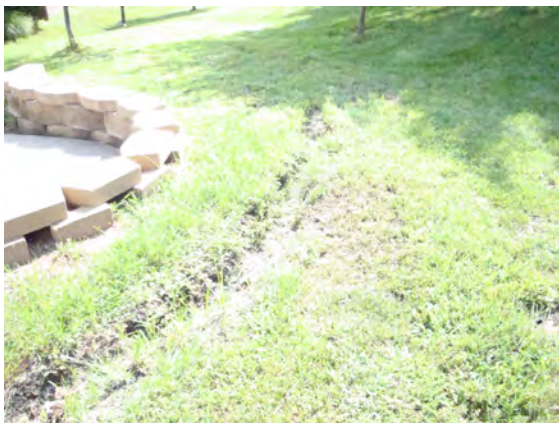
8. Southeast corner of Community Center: The runoff from the building and parking areas run to the low point at the north curb line of the parking area and must flow through the narrow curb opening in the curb there. The water backs up onto the parking lot and ponds frequently. The water then drains through an open graded swale that remains wet and spongy. This is a problem for maintenance and is a potential source for mosquito breeding.

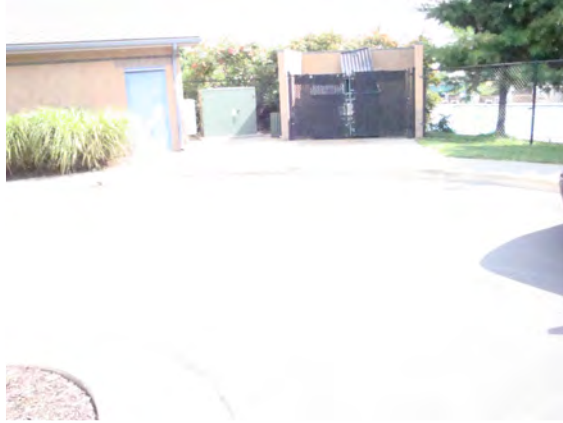
9. Northeast corner of Community Center: The runoff from the building and parking areas run to the low point at the north curb line of the parking area and must flow through a small drilled hole through the curb. The hole plugs easily and the water backs up onto the parking area and ponds for a long period after rains. The excess water must overtop the curb and run over the sidewalk and past the power transformer in this area before escaping away to the north.
